# Independent Monitor Community Report

2009 Operational Period

Community Report by the Independent Monitor of the  
McArthur River Mine, November 2010

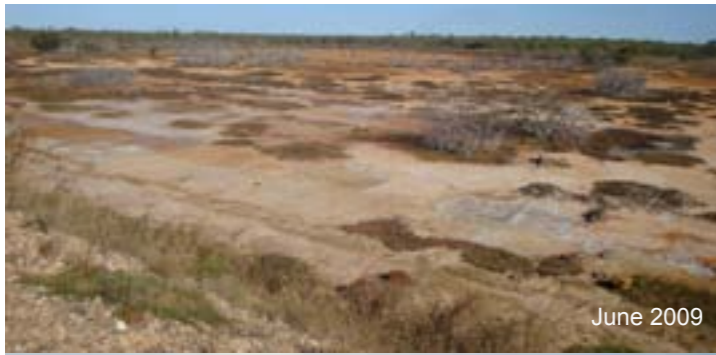
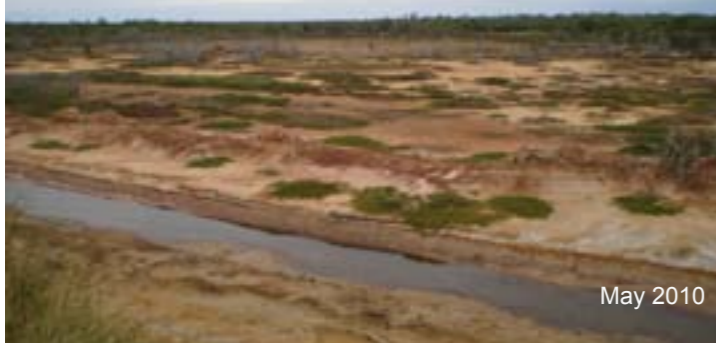
Last year we noticed significant vegetation die-back immediately outside the dredge spoil ponds at the Bing Bong Port Facility. The dredge ponds are built to hold marine sediments (spoil) dredged from the Bing Bong swing basin. It was evident that the vegetation dieback was being caused by saline seepage leaking from the salty spoil, through the degraded pond walls and onto the surrounding plain.

**Top:** Salt-affected land and vegetation outside of the Bing Bong Dredge Spoil ponds in June 2009. **Bottom:** The same area in May 2010 after the installation of a perimeter spoon drain, which is seen in the foreground. Vegetation is seen to be regenerating outside of the spoon drain.

MRM has since installed an outer spoon drain, which drains the saline seepage from the spoil back to sea. Previously-eroded pond walls have also been re-constructed, however due to the poor quality of construction materials, seepage through the pond walls is expected to continue. MRM will be completing additional capital works at the dredge spoil ponds before the commencement of the 2010/2011 wet season.

Although seepage continues, the spoon drain appears to be successful in re-directing saline seepage back to sea and allowing vegetative regeneration in the previously-affected areas. We will continue to monitor the success of vegetation in this area. Further geotechnical assessments of the dredge spoil walls have also been recommended.

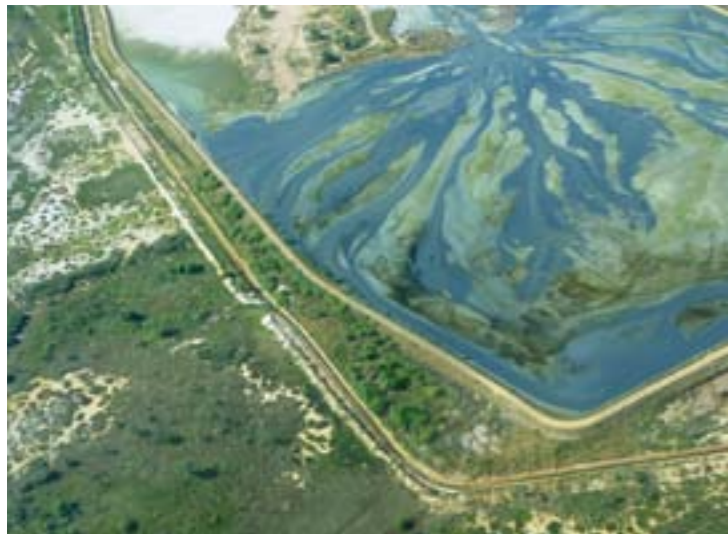
Aerial view of the northern-most Dredge Spoil pond with perimeter spoon drain, and dredged material and sea water radiating from the central deposit point in the middle of the spoil pond (May 2010).

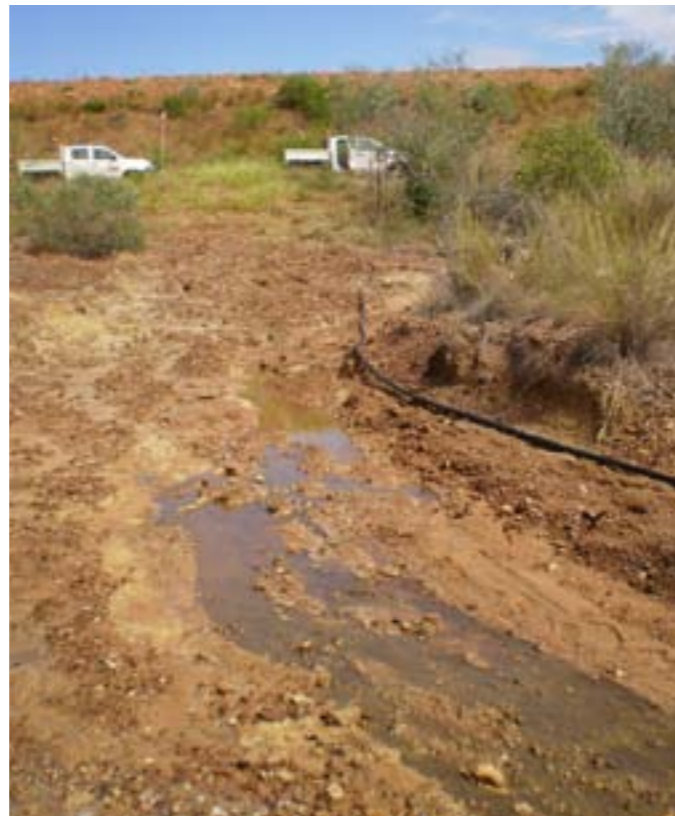
Although leachate is still being expressed at the toe of Cell 1, and is draining towards Surprise Creek, (see picture below), we commend MRM for undertaking additional mitigation measures over the past year, including:

Leachate draining from the base of TSF Cell 1 towards Surprise Creek. A sump has been constructed to collect some of this leachate, but more work is needed (May 2010).

- a sump to intercept surface leachate draining towards Surprise Creek;
- electromagnetic survey to identify key areas of conductivity and likely seepage from the Cell;
- ongoing advice and investigation from external consultants;
- cessation of pumping reclaimed leachate back on top of Cell 1; and
- continuation of the clay capping (which will be completed before the 2010/2011 wet season).

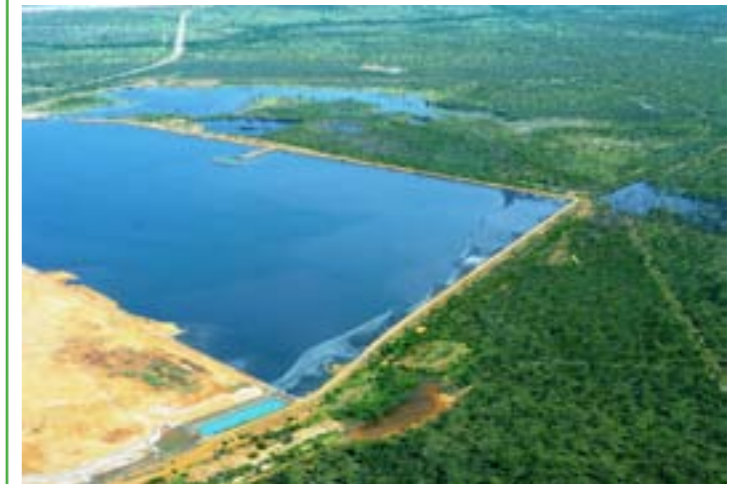
The Independent Monitor is concerned about the amount of water being stored within the TSF Cell 2, which is currently receiving tailings waste from the Mine. This excess water storage poses the risk of overtopping the TSF walls or causing the embankment to fail all together. We recommend that the water stored in this Cell be reduced, and that MRM increase quantitative geotechnical monitoring within the embankments.

There is a large volume of water being stored in TSF Cell 2 as seen above. The water management dam (top left of the photo) receives excess water spillover from Cell 2, but the amount of water stored, in the Cell should be reduced (May 2010).

MRM are conscious of the amount of water in Cell 2, and as such, are taking steps to increase the use of recycled water.

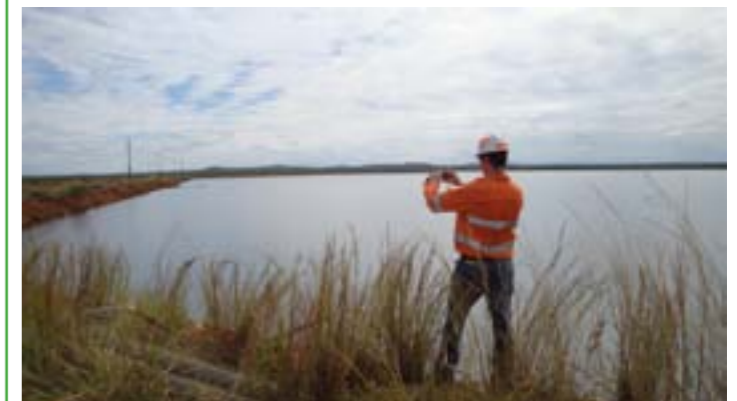
Independent Monitor team geotechnical engineer inspecting the excess water storage in TSF Cell 2 (May 2010). As seen above, at the time of our inspection, there was only approximately 1 metre of freeboard available in Cell 2. The available freeboard should be increased to reduce the risk of overtopping.

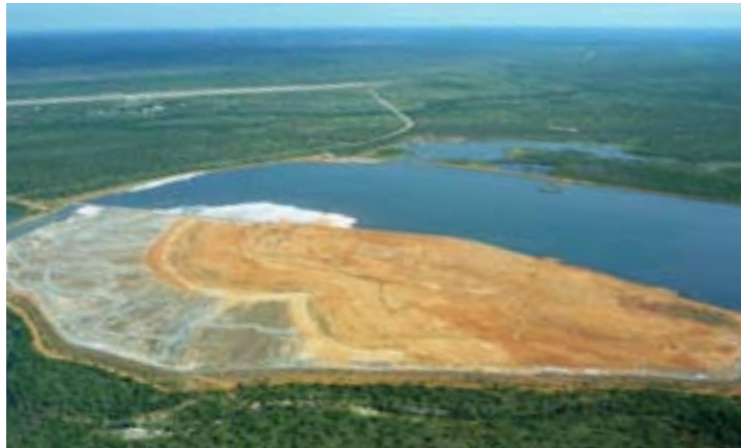
Leachate migration from Cell 1 into Surprise Creek continues to be an issue this audit. While investigations and some mitigation measures have been undertaken since the last audit (as mentioned previously), further work will be ongoing.

The clay capping of TSF Cell 1 was approximately 60% complete during our inspection in May 2010, as seen above. The rest of the capping is to be completed by the 2010/2011 wet season to reduce infiltration of water through the exposed tailings and reduce dust generation.

- geochemical assessment of the tailings in Cell 1;
- increased quantitative monitoring rather than qualitative;
- installation and monitoring of piezometers within the TSF embankments; and
- completion of the clay capping of Cell 1 to limit rainfall infiltration.

Next audit we will request as-built reports for Cell 1, and evidence that the clay cap has been tested to meet design specifications.

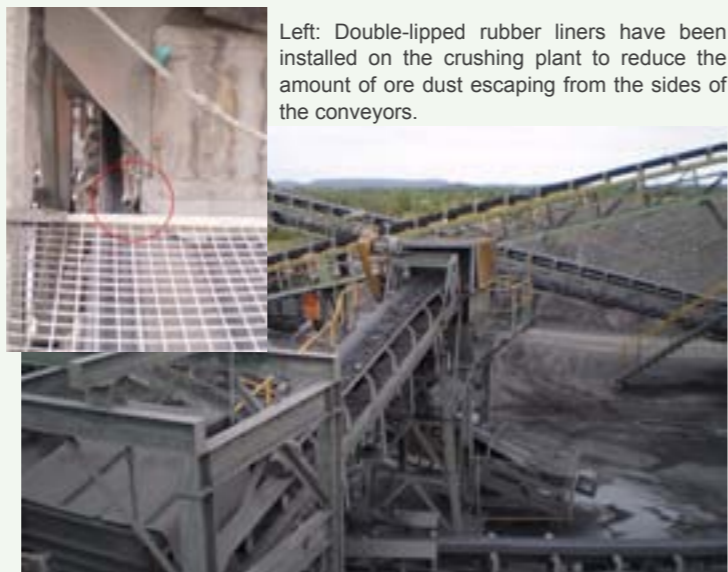
Our primary concern regarding dust at the mine site is the dust generated by the ore crushing plant. The plant, which is a system of conveyors and crushers, has recently been upgraded with double-lipped rubber liners to reduce dust escaping from the sides of the conveyor belts (see photo inset top right). Water sprays are also used throughout the plant, and other dust reduction measures are to be installed.

Left: Double-lipped rubber liners have been installed on the crushing plant to reduce the amount of ore dust escaping from the sides of the conveyors.

The ore crushing plant that operates on the mine site is a source of ore dust-generation, which can contaminate soil and water. Steps are being taken to limit dust from this facility.

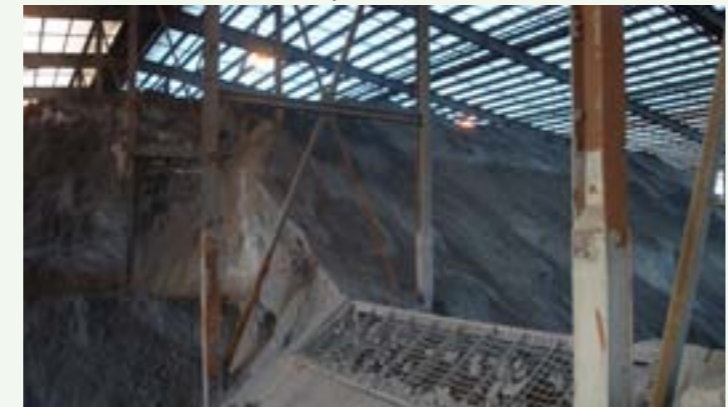
Fugitive dust migration from the Bing Bong Port concentrate storage shed also continues to be of concern. The roller doors of the concentrate storage shed remain open at all times due to potential sulfate gas build-up within the shed. This practice increases the opportunity for dust to escape from the shed and contaminate surrounding soil, sediments and seawater.

Zinc concentrate is stored within the Bing Bong concentrate storage shed while awaiting loadout onto the Arburri barge for shipment. The doors of the shed remain open to limit gas build-up that corrodes shed infrastructure. However, the open doors also allow concentrate dust to escape and spread via the wind to potentially contaminate soil, water or and sea sediments. This past year, damaged sections of the warehouse corrugated iron roof were replaced with fibreglass roofing that is resistant to the corrosive gases. The upgrade of the roof will assist in reducing dust emissions at the load out facility

MRM have advised that they are exploring upgrades to shed ventilation so that the doors can remain shut. We commend MRM for undertaking a recent dust audit at Bing Bong, which we will review next year.

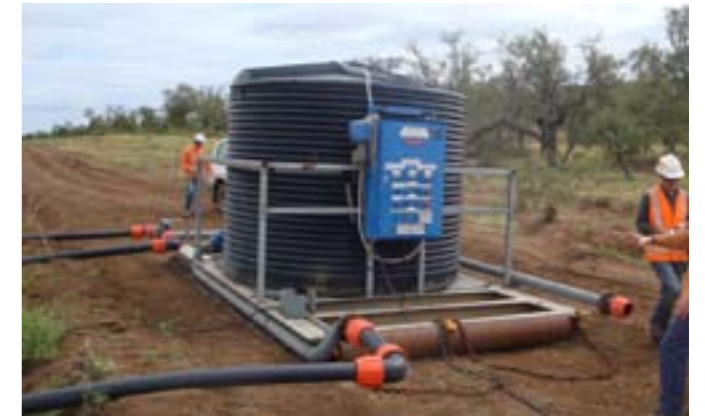
Revegetation along the McArthur River diversion has been slow to establish due to the velocity and volume of wet-season flooding. Previous attempts to establish a dry-season irrigation system along the McArthur River Diversion were not overly successful as high-volume and velocity flood waters destroy irrigation infrastructure. However, the implementation of a sled-mounted irrigation system, which can be moved to higher ground in times of flood, will hopefully aid vegetation establishment over the 2010 dry season.

MRM have utilised a new irrigation sled to help establish vegetation along the McArthur River diversion channel over the 2010 dry season (May 2010).

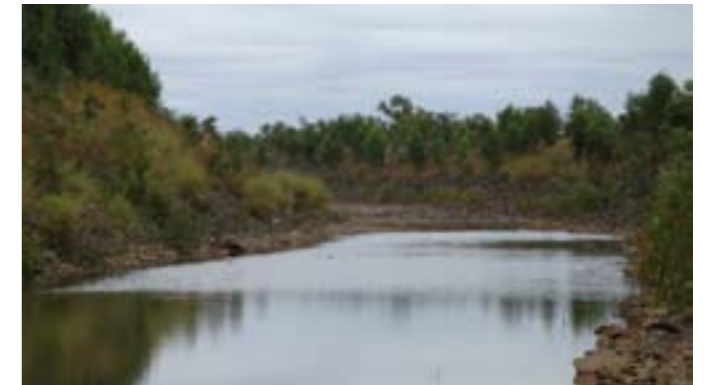
Revegetation of the Barney Creek diversion channel is going well. Each audit we have observed increasing vegetation establishment at this location (May 2010).

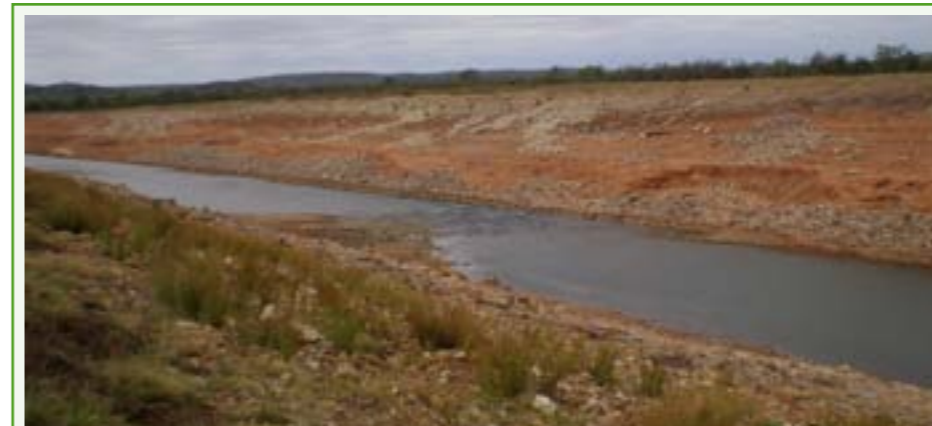
Minor slumping erosion and scour can be seen along the McArthur River diversion channel. Vegetation establishment, may help stabilise the banks of the diversion throughout the wet season floods. (May 2010)

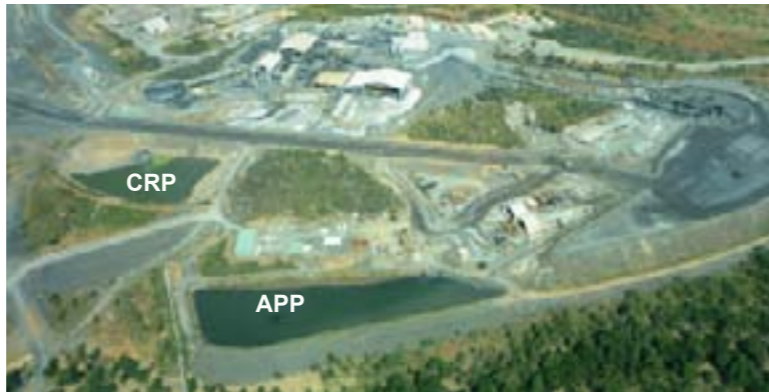
Monitoring of artificial surface waters is undertaken at all water dams across the Mine site and at Bing Bong on a monthly basis. The above photograph shows the Concentrator Runoff Pond (CRP) and Anti Pollution Pond (APP) at the Mine site. The 2009 data collected by MRM indicated that the CRP may be leaking, and MRM have proposed investigation and mitigation strategies in response. (May 2010).

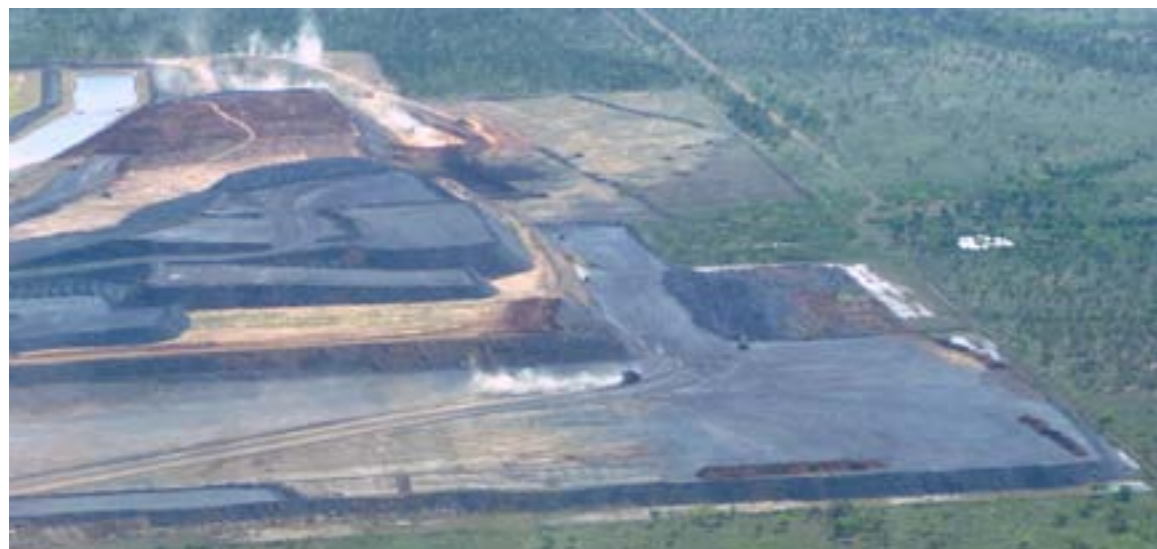
This year we saw sufficient evidence that the clay is being tested before it is placed at the OEF; however, we have not seen any documented evidence that testing is undertaken after placement. We will again request MRM to provide this next year.

The clay layer that lines the base of the OEF is an essential part of the OEF design. The clay acts as a barrier to stop the migration of any acid production that may occur within the OEF waste rock. It is essential that the chemical and physical nature of the clay is tested before and after it is placed at the OEF to ensure its suitability. (May 2010).

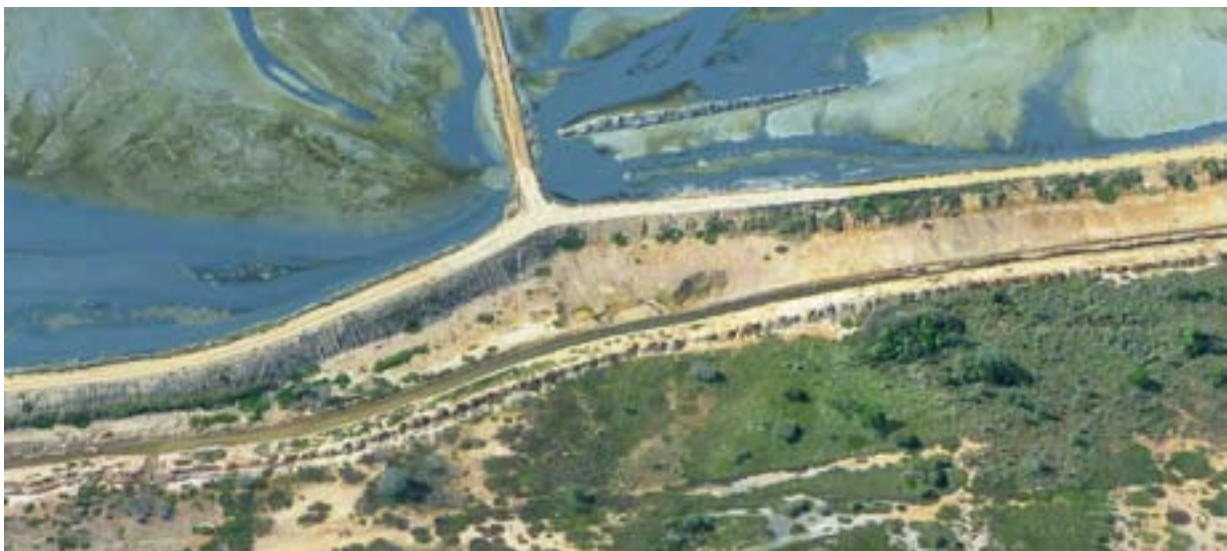
We will continue next year to monitor many of the issues identified during this audit and previous audits, such as the regeneration of salt-affected vegetation outside the Bing Bong dredge spoil ponds. It is anticipated that the recently-constructed perimeter spoon drain (as seen above) will help mitigate this issue. (May, 2010)
