MAGNT RESEARCH REPORT No. 9

THE HISTORIC SHIPWRECK *AUSTRALIAN*: A PLAN OF MANAGEMENT

DAVID STEINBERG

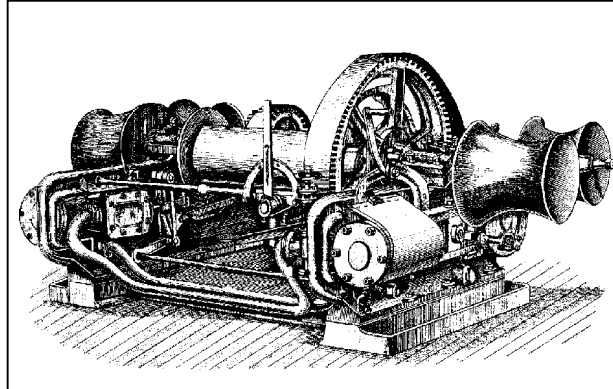
Fig. 16. A steam driven winch (Paasch 1977: plate 61)

The windlass, winches and anchor machinery. The *Australian* was equipped with at least four winches, one for each cargo hatchway. The winches were used to haul cargo, and may have been utilised to raise and lower sails. Figure 16 below shows the design of a steam driven winch, similar to those installed on the *Australian*.

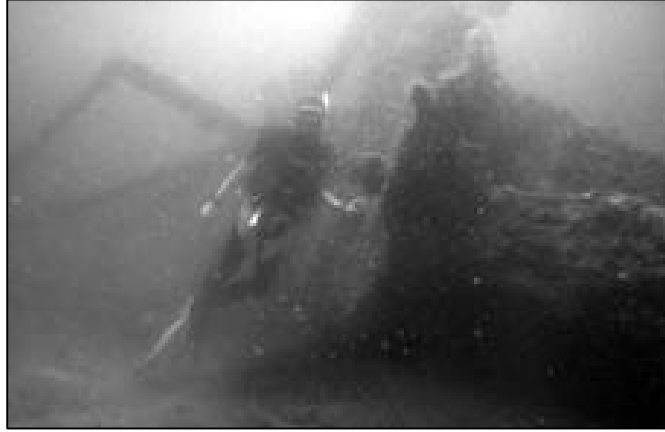
Fig. 24. The remains of the bow (photo: J. Riley)

The bow section. The bow has broken away from the ship and has fallen forward and to starboard (Fig. 24). The bow at present still retains its rounded three dimensional form. The upturned port side of the bow maintains all of its hull plating and displays a hawse pipe, distinctive mould lines and a set of fairleads, the latter was used to secure the bowsprit to the foredeck. Also attached to the structure, alongside the port side, is the remains of the sheerstrake frame for the raised deck. Except for a small, forward steel portion, the deck of the bow is absent creating a cavernous region, which is highly populated by fish life. At low tide the rear port portion of the bow breaks the surface of the water.

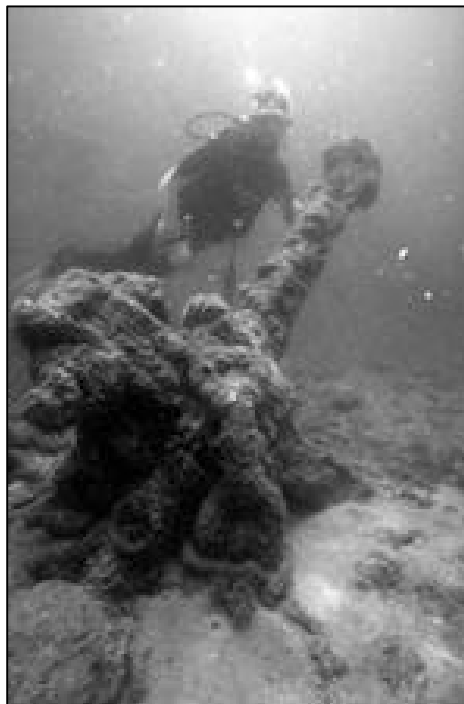
Fig. 25. The anchor *in-situ* (photo: J.Riley)

Located 5 metres to the west of the bow is a Trotman's anchor standing upright and half buried (Fig. 25). This may be the port bower anchor. A length of the shank and the stock is exposed. An anchor ring or shackle also remains attached to the anchor through its eye. The height of the exposed portion of the shank is 1.5 metres and has a diameter of 0.7 metres. The anchor ring has a diameter of 0.3 metres.

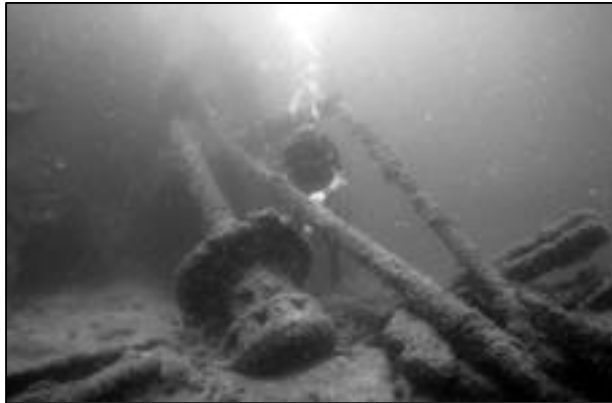
Fig. 26. The capstan and anchor crane *in-situ*, located at the bow. (photo: J. Riley).

Much of the foredeck has collapsed leaving a swim-through into the interior of the bow. All that remains of the foredeck is a small portion of steel decking, known as the deck hook, which is fixed at the very peak of the bow. The head of the capstan and the top of the anchor crane are deposited on the seafloor outside this cavern (Fig. 26). The legs of the anchor crane and the shaft of the capstan still reach into the remains of the bow's lower deck section. Also protruding from the internal bow structure are the port and starboard hawse pipes. The remains of the collision bulkhead are visible within the bow and this probably contributes to much of the structure's remaining strength.

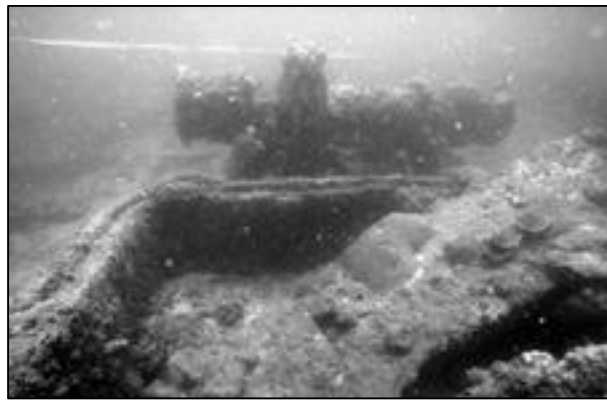
Fig. 27. The forward winch *in-situ* (photo: J. Riley).

The winch is bordered by a raised frame, measuring 2.15 metres square. The winch itself appears in good condition. Its overall dimensions are approximately 1.15 metres by 2.8 metres in length and is 1.10 metres in height. The warping ends (spools that work the chain or rope) and the main piece, (part of the driving mechanism), are distinguishable and visibly impressive features. There is a foot pedal reaching out into the water. The hatchway is a rectangle of 2.50 metres x 3.60 metres. However, it is possible that these are not the original dimensions. The raised frame of the hatchway is intact.

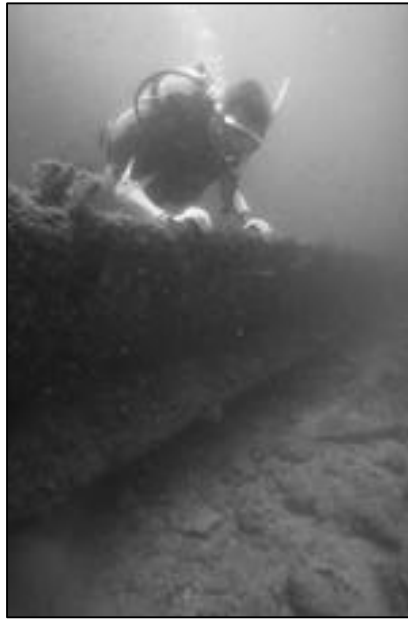
Fig. 28. The port bilge keel *in-situ* (photo: J.Riley).

The most revealing remains of the hull are found along the port side of the wreck. Here a significant portion of the ship floor and hull double bottom is exposed for investigation. This section is approximately 70 metres long. This visible material allows one to investigate the design of the ship floor, lower hull and the cellular double bottom. In turn this section of the remaining hull is raised off the seabed to the extent that the port bilge keel is exposed and can be studied (Fig. 28). The role of the bilge keel was to contribute to ship stability.

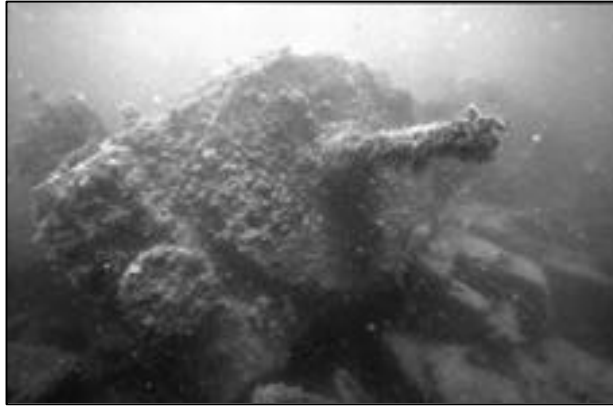
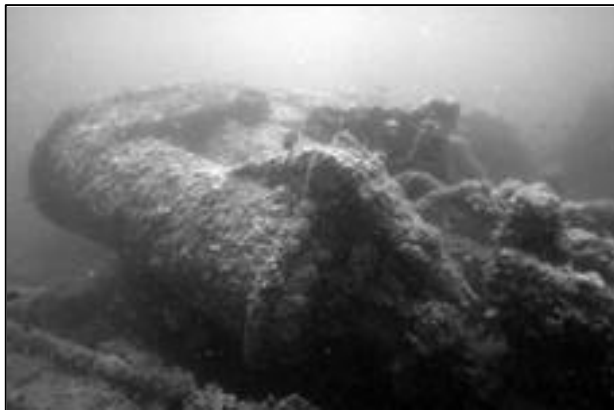
The high and intermediate cylinders constitute the smaller section of the engine, the low pressure cylinder being substantially bigger (Figs 30, 31). Inspection of the engine has indicated that the exhausted steam from the low pressure cylinder valve chest was routed through the hollow cast iron port support column to be fed into the condenser. This is an adaptation in design to save valuable space.

Fig. 30. The low pressure cylinder section of the propulsion engine *in-situ*. (photo: D.Steinberg).

Fig. 31. The high and intermediate pressure cylinders section of the propulsion engine *in-situ* (photo: D.Steinberg)

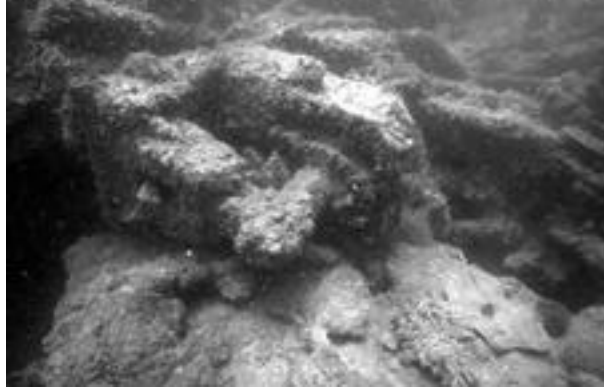
Fig. 32. The dynamo *in-situ* (photo: D. Steinberg).

The remains of the water filters, dynamo and twin refrigeration machines appear in good condition. The outer surface of these still remain intact. These surfaces are covered in small hard corals and a thin layer of concretion. In particular the dynamo illustrates much of its design with the driving shaft and cylinder still intact and clearly visible (Fig. 32). Further investigation may indicate if the dynamo pulley was fitted for belts or ropes, this distinction in design highlighted by Guthrie (Guthrie 1971: 277). The remains of the refrigeration systems show the flywheels, once powered by the cylinder of the expansion unit (Fig. 33). As part of the refrigeration process the working of a cylinder was to expand and cool the steam.

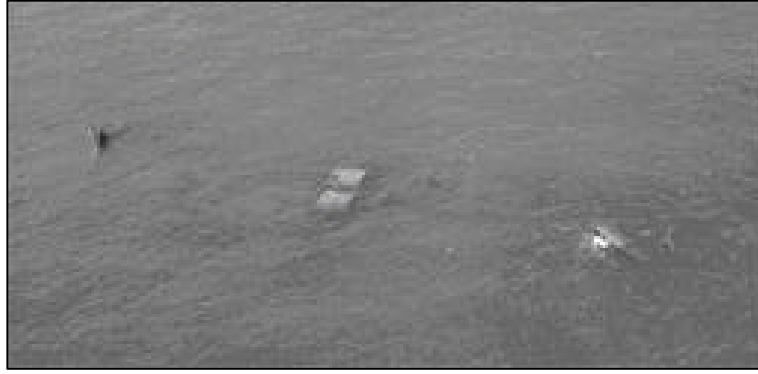
Fig. 34. Aerial photograph of the *Australian*; the bow, boilers and stern are visible (photo: NT Parks and Wildlife Commission 1998).

The shipwreck is partially exposed at low tide, when the bow and stern structures break the waters surface. At high tide the bow, boilers and stern sections are visible from the surface of the water (Fig. 34). There is no fixed buoy or marker on the site. There are also no signs at boat launches in the vicinity which indicate the location of the *Australian*.

Recommendation 6: that anchoring directly onto the shipwreck be prohibited as a provision of the CMPPM . This restriction should include using the bow or stern as a mooring fixture, when these features are exposed at low tide.
