# Independent Monitor Community Report

2009 Operational Period

Community Report by the Independent Monitor of the  
McArthur River Mine, November 2010

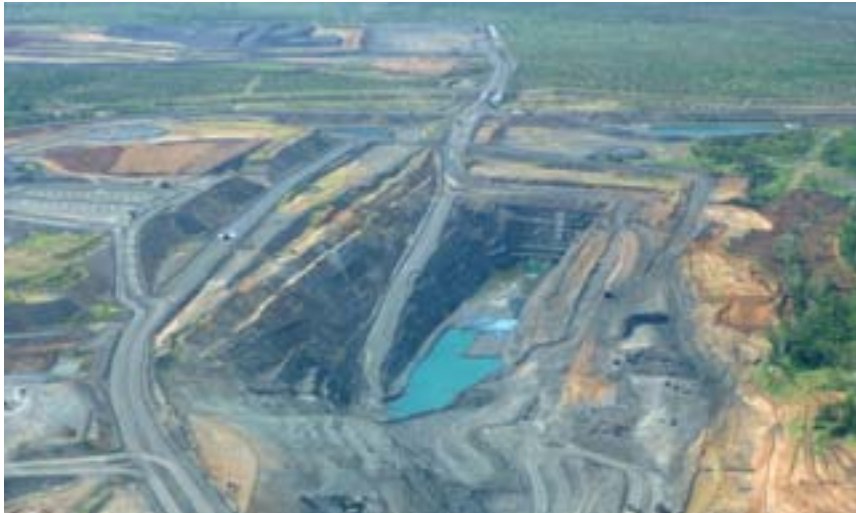
The open cut pit of the McArthur River Mine, as viewed by the Independent Monitor during the May 2010 site inspection.

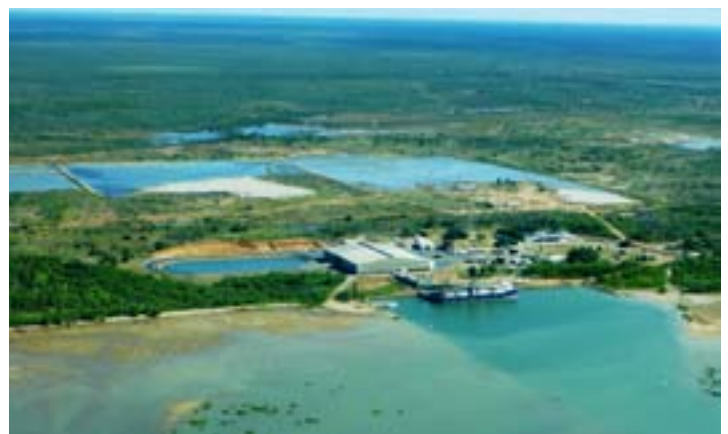
Last year we noticed significant vegetation die-back immediately outside the dredge spoil ponds at the Bing Bong Port Facility. The dredge ponds are built to hold marine sediments (spoil) dredged from the Bing Bong swing basin. It was evident that the vegetation dieback was being caused by saline seepage leaking from the salty spoil, through the degraded pond walls and onto the surrounding plain.

Aerial view of the Bing Bong Port Facility with the Bing Bong Port and concentrate storage shed in the foreground, and the dredge spoil ponds in the background. (May 2010).

Although seepage continues, the spoon drain appears to be successful in re-directing saline seepage back to sea and allowing vegetative regeneration in the previously-affected areas. We will continue to monitor the success of vegetation in this area. Further geotechnical assessments of the dredge spoil walls have also been recommended.

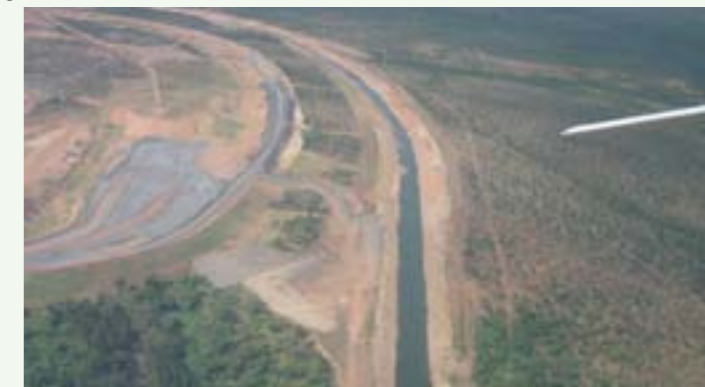
The above photograph shows the upstream end of the McArthur River Diversion, and the cut off section of the old McArthur River channel to the bottom left. During times of flood, water passes overland between the two.

We recommend that the as-built diversion channel works be 'tested' by inserting as-built channel cross sections into the detailed design hydraulic model. This should include

associated reporting as to how the as-built channels compare against the various project commitments and design intents.

Sedimentation and erosion photograph monitoring at intervals along the diversions is considered acceptable, however we also recommend that opposite bank photographs also be taken. Further, we recommend that current erosion monitoring be combined with Digital Elevation Model (DEM) data to provide a clearer and more comprehensive picture of erosion and sedimentation along the diversions.

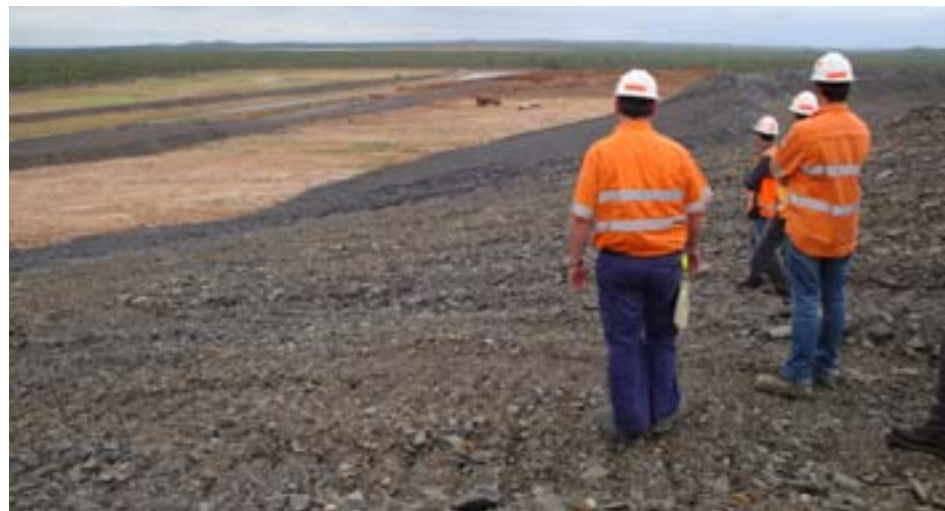
The Independent Monitor team inspected the progress of the Overburden Emplacement Facility in May 2010. The OEF receives waste rock or 'overburden' from the mine pit. Some of the waste rock has the potential to form acid if it is exposed to water and air, so the proper placement of 'potentially acid-forming' and 'non-acid forming' rocks is essential to avoid environmental damage from releasing acid into the environment.

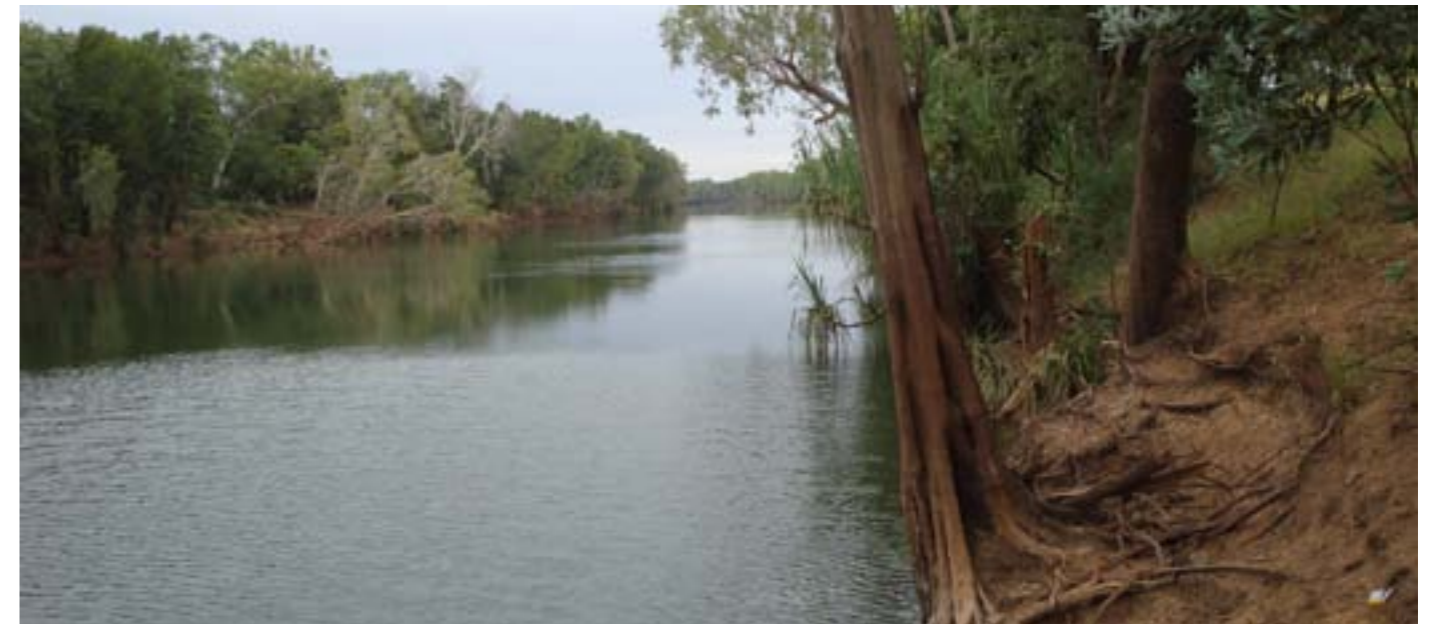
The Independent Monitor inspected a tributary upstream of the McArthur River Diversion called 8-Mile Creek (above). Freshwater Sawfish have been caught and tagged at this location as part of MRM's Freshwater Sawfish monitoring program. (May 2010).

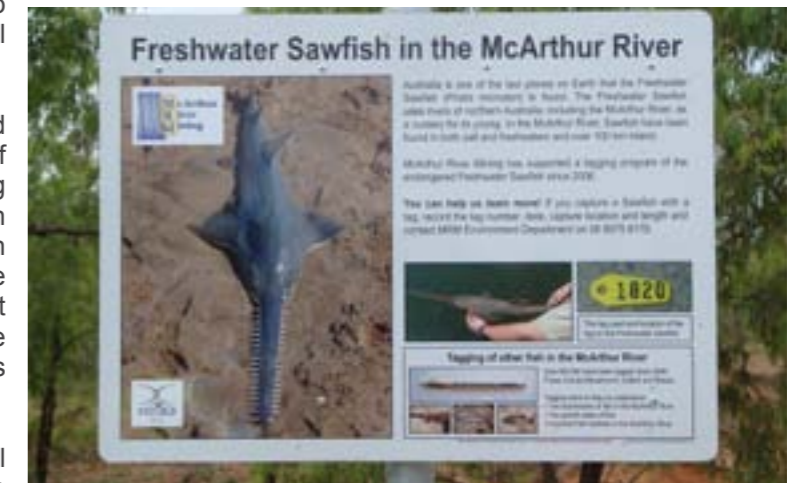
Signs such as this are placed along the McArthur River to encourage fishermen to alert MRM if they catch and release a Freshwater Sawfish in the McArthur River. This helps MRM keep track of sawfish movements and abundance in the McArthur River. (May, 2010).

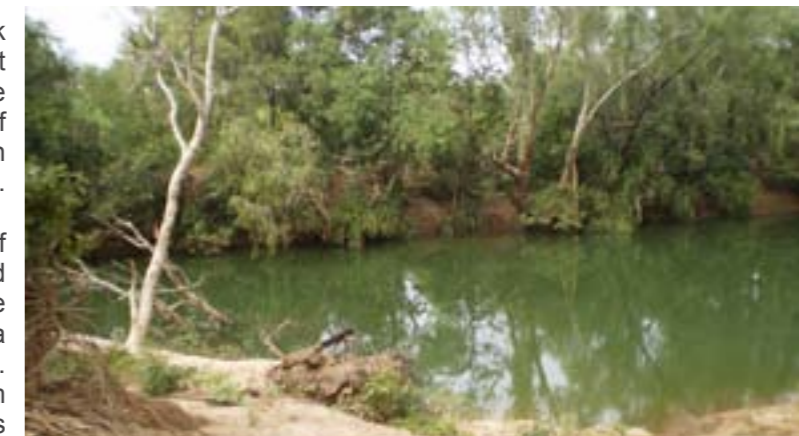
This area of the McArthur River, upstream of the diversion channel is used as an analogue site for riparian flora and fauna monitoring. This area provides an ecological benchmark for the eventual revegetation and rehabilitation of the McArthur River diversion channel. (May, 2010).
