## Is your house safe in a cyclone?

### Inspection Guide for Buildings in Cyclonic Regions of the NT

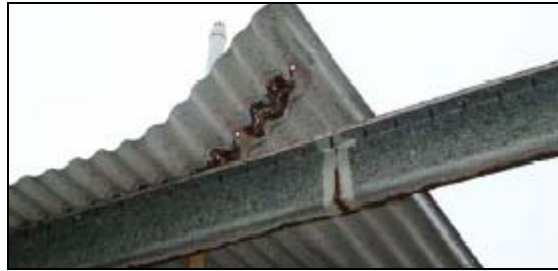
Corroded screws and cladding

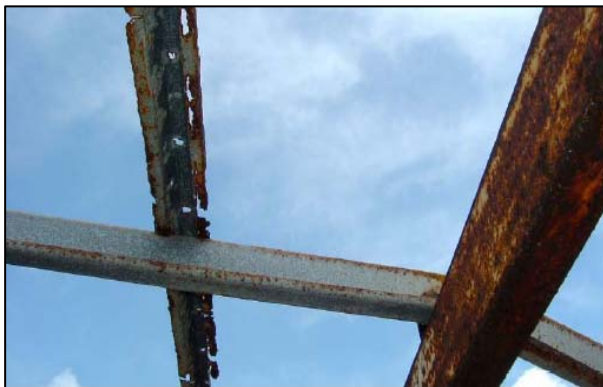
Corrosion of top hat batten

Corrosive environments can affect steel structures, reinforcing steel in concrete structures, metal cladding, metal battens, bolts, fixing plates and fixings such as cyclone assemblies (screws) and metal batten straps. This is particularly relevant to areas that are in close proximity to the coast.

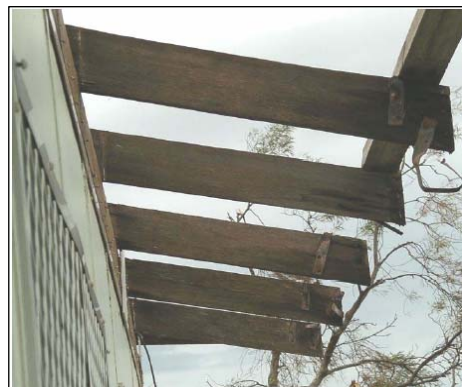
Corroded batten straps

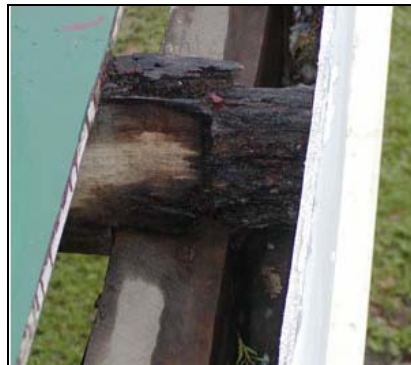
Deteriorated timber  
(Floor joist at external wall connection)

Timber is affected by moist damp conditions. Wet rot is basically timber decaying naturally in the presence of high levels of moisture. This can affect structural components such as bearers, joists, flooring, timber external cladding and timber framing - particularly in exposed locations or where water leaks are present.

Climatic conditions such as high humidity, high rainfall, strong winds and long dry periods can cause structural components to shrink or expand and to deteriorate over time within the building. Effects of weathering could be to loosen tie-down bolts or fixings. Regular maintenance should be undertaken to eliminate loose fixings and replace deteriorated timbers.
